# Manhole Inspection Summary

Manhole # **S43CC\_046MH**

Insp Date: **12/19/07 10:13 AM**

**Location** Address: **arnold ct**

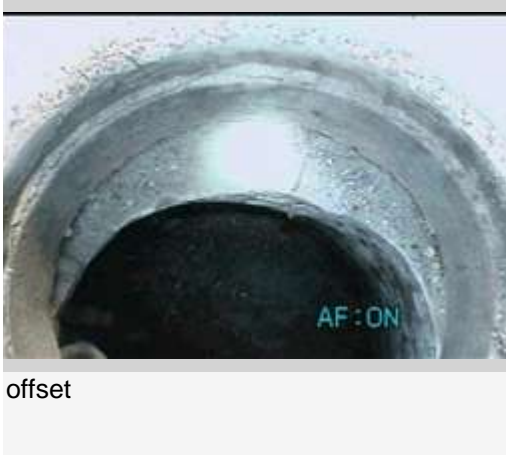
Defect 1

Condition: ☐ Sound ☐ Cracked ☐ Root Intrusion ☐ Deteriorated ☐ Leaks ☒ **Debris**

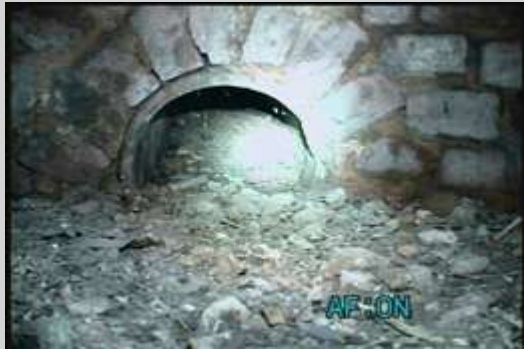
12 O'Clock Outflow

8 in. Circular Gravity Sewer  
Pipe Out @ 12 O'Clock

Deposits: ☐ None ☐ Mud ☐ Sludge ☒ **Debris** ☐ Grease

Silt Depth: **3** (in.) Deposits Extent: **Heavy**
